Suspect/Counterfeit Bolts Found Installed in TD Forklift Trucks

TD-08-032

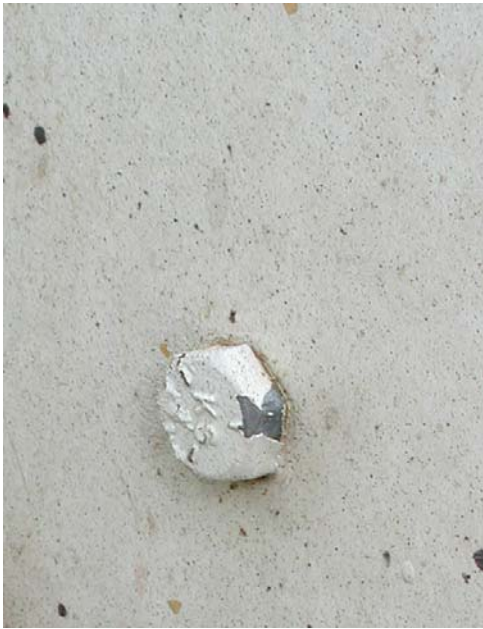
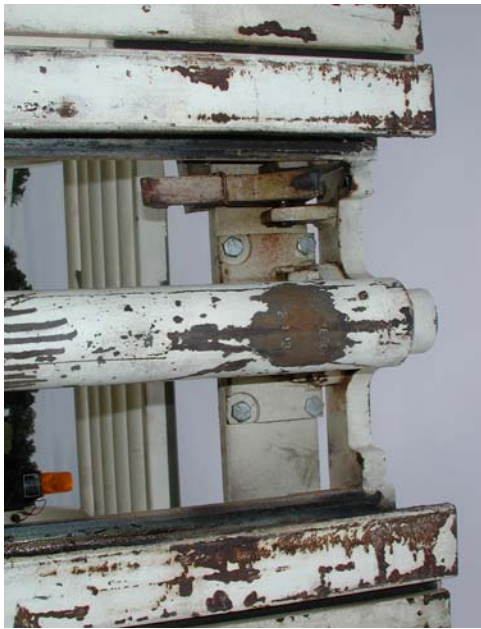
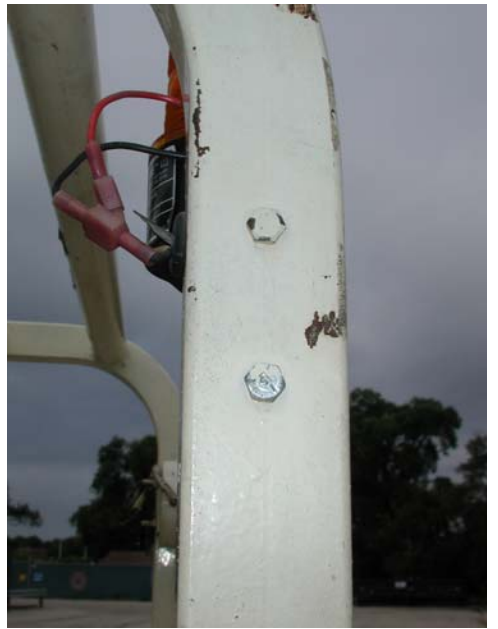
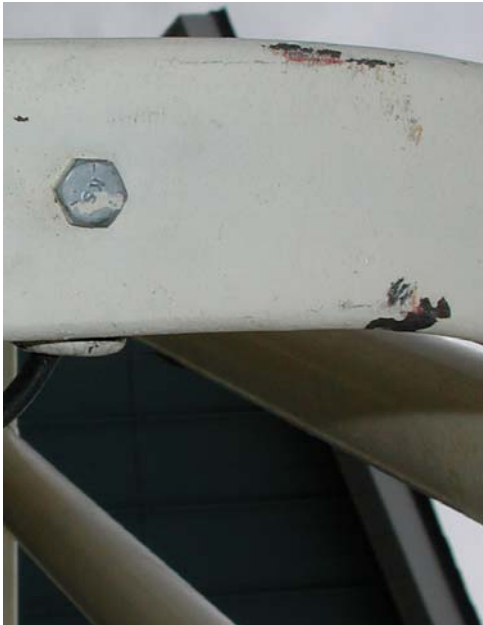
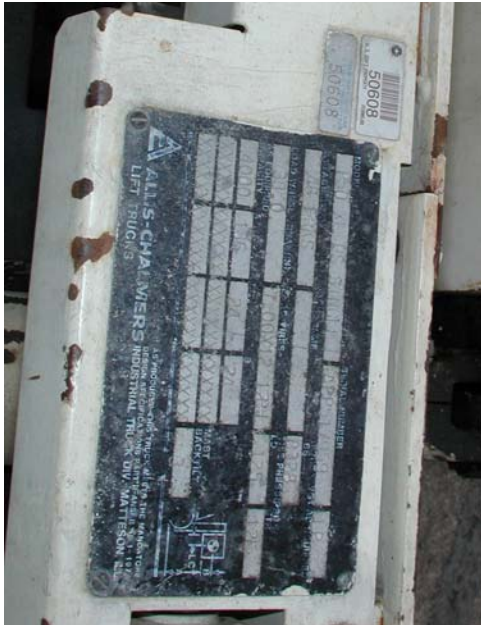
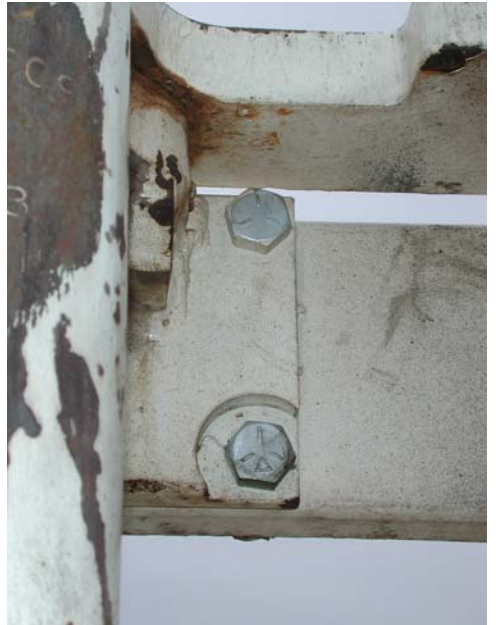
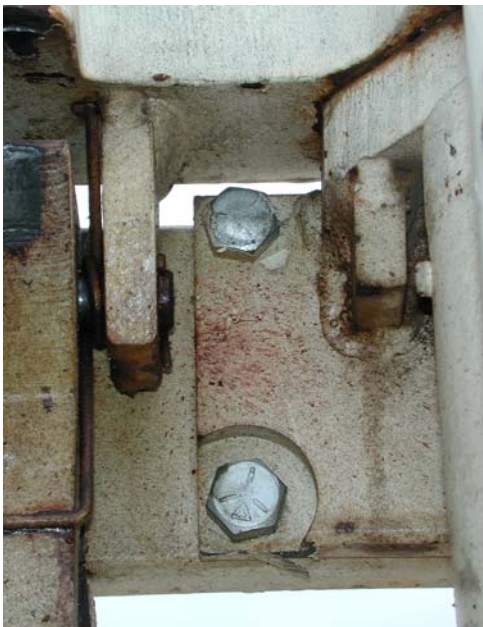
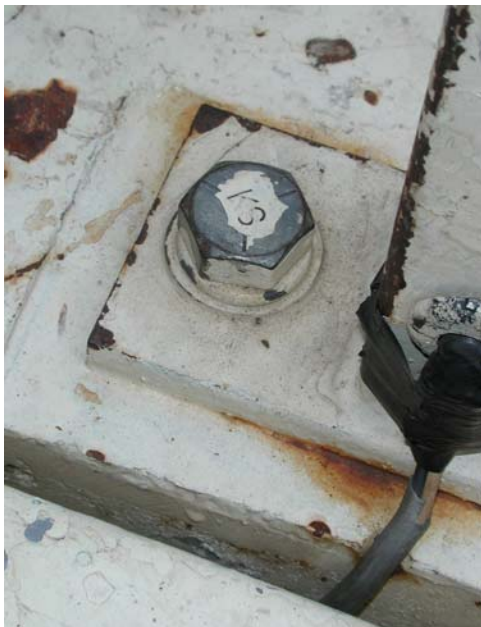
Forklift # 50608

On 03-Sep-2008, Ted Beale (QC Supervisor, Quality & Materials Department) performed a visual inspection of an “older” forklift truck, looking for suspect/counterfeit bolts. The training recently given at Fermilab indicated that older trucks have a reasonable likelihood of containing S/C bolts. His inspection showed that several of the installed bolts were indeed on the DOE S/CI headmark list.

Since some of the bolts were in load-bearing positions, so the truck was taken out of service by tagging the key as such.
